# State of the River Asker Summary

03/01/2019

## State of the River Asker Summary

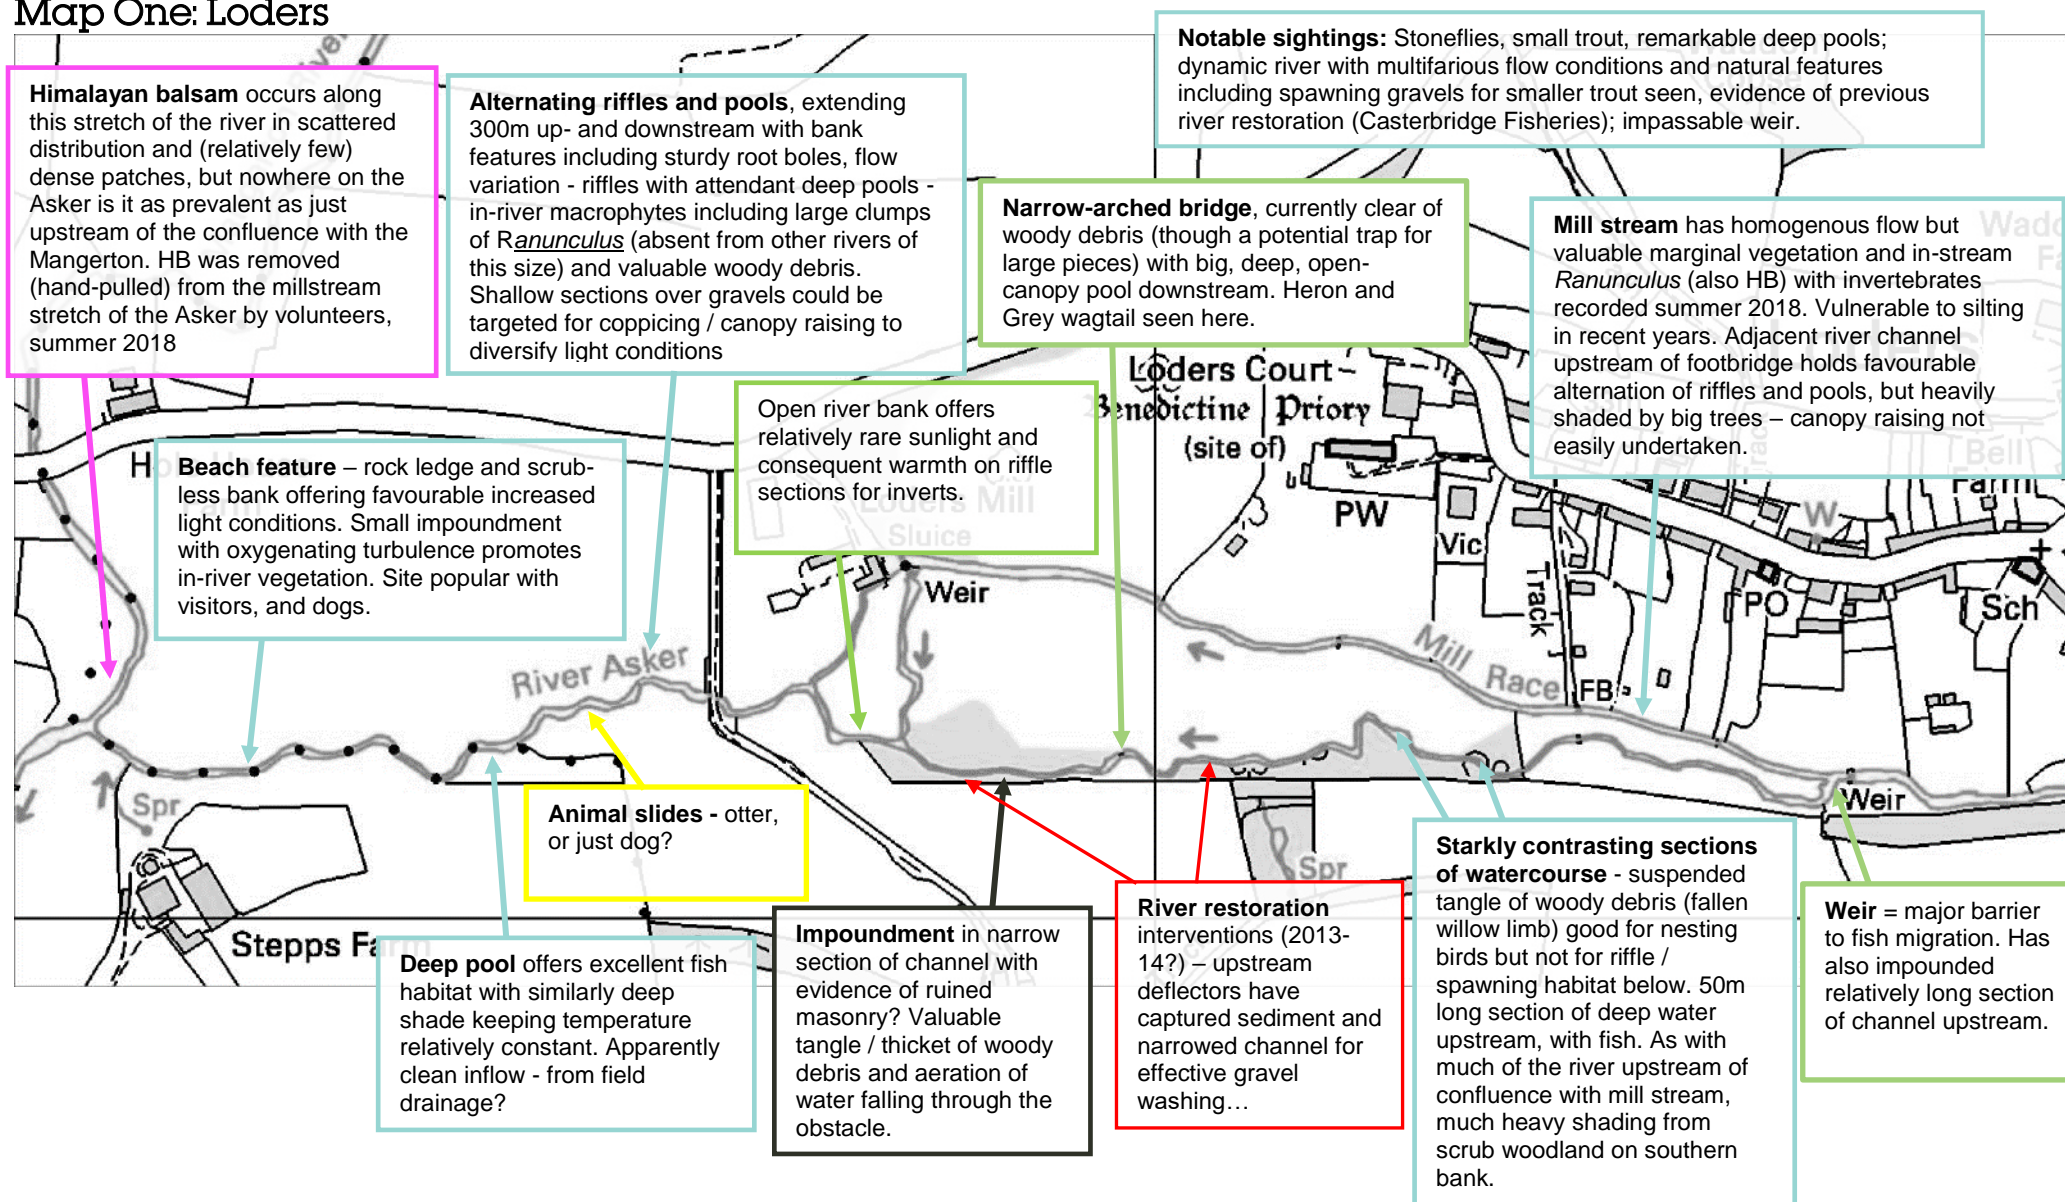
## Map One: Loders

Alternating riffles and pools, with abundant bank features, flow variation and valuable woody debris – root boles with attendant deep pools and shallow sections over gravels which could be targeted for coppicing / canopy raising. Gardens at river's edge (south side) result in varying light conditions.

Small tributary, fenced and almost entirely shaded by recently coppiced willow and hazel. Open sections hold pollen and nectar-rich plants, e.g. Red campion.

Wooded section of river bank with valuable wet woodland patches. Himalayan balsam pulled several times a year. Some trees identified for canopy raising to complement light-increasing activity on south side of river.

Signal crayfish claw found.

Valuable alternation of riffles and pools along long, naturalistic section of river upstream of Upton. Some natural flood management opportunities using e.g. root boles though these may be better placed further upstream in headwaters

Japanese knotweed

Jordan Brook – wide, rushy, muddy channel with sections of open, shallow water, apparently alive with invertebrates and foraging birdlife. On balance, livestock impact noted as positive. Appealing, grazed valley and floodplain with marginal vegetation on strip lynchets contributing to wildlife food sources.

Unusually open section of river – bountiful sunlight has resulted in abundant channel vegetation and associated invertebrates. Suspected Water vole activity but no evidence recorded.

Sections of engineered channel along road with culverts, subject to recent hard engineering. Also, valuable floodplain lakes and ponds.

Otter spraint on in-river boulder  
 – prominent marking.
