River Winniford Testing 2023

WRAG

CHIDEOCK
PARISH
COUNCIL

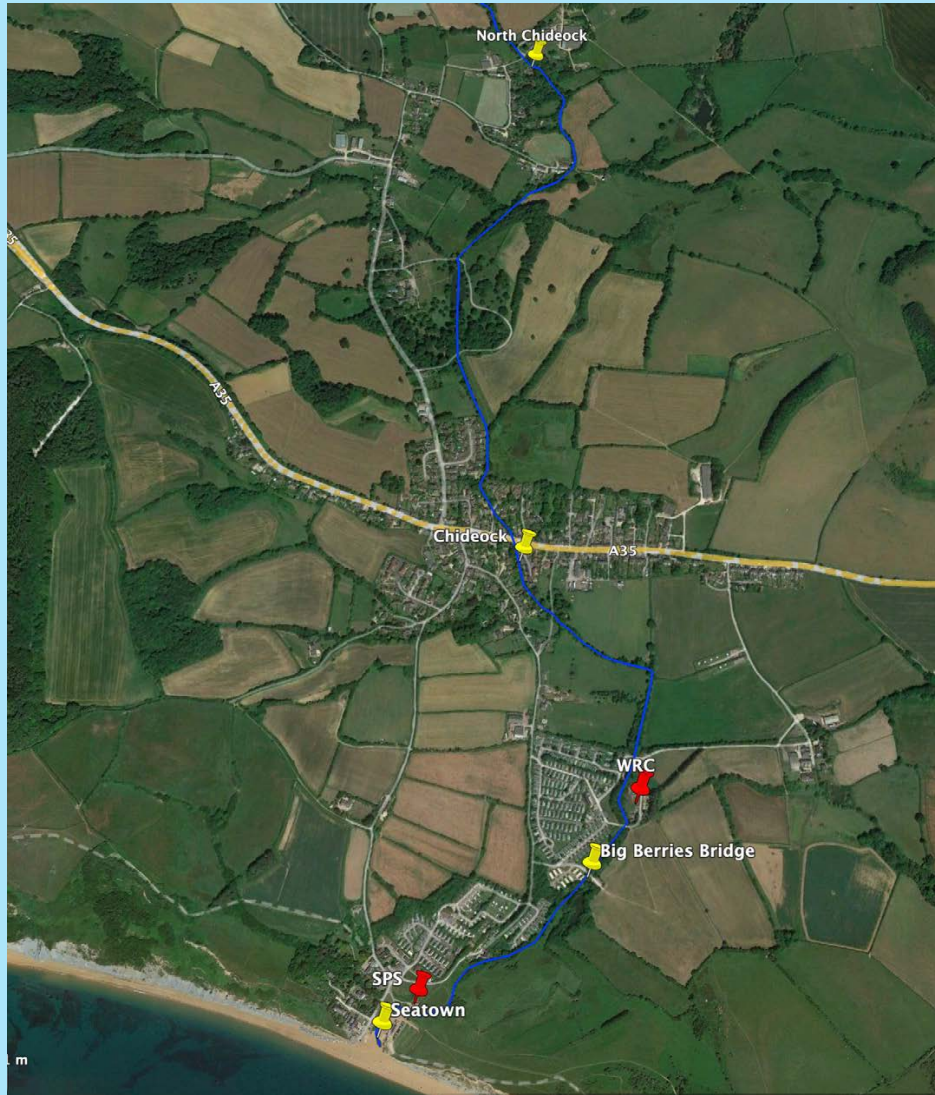
Initial testing locations

4 test locations (yellow):

- North Chideock (member garden)
- Chideock Village (member garden)
- Big Berries: Near WRC outfall (WDLH)
- Seatown Car Park (Palmers pub)

Wessex Water assets (red):

- Chideock Water Recycling Centre (WRC)
- Seatown Pumping Station (SPS)

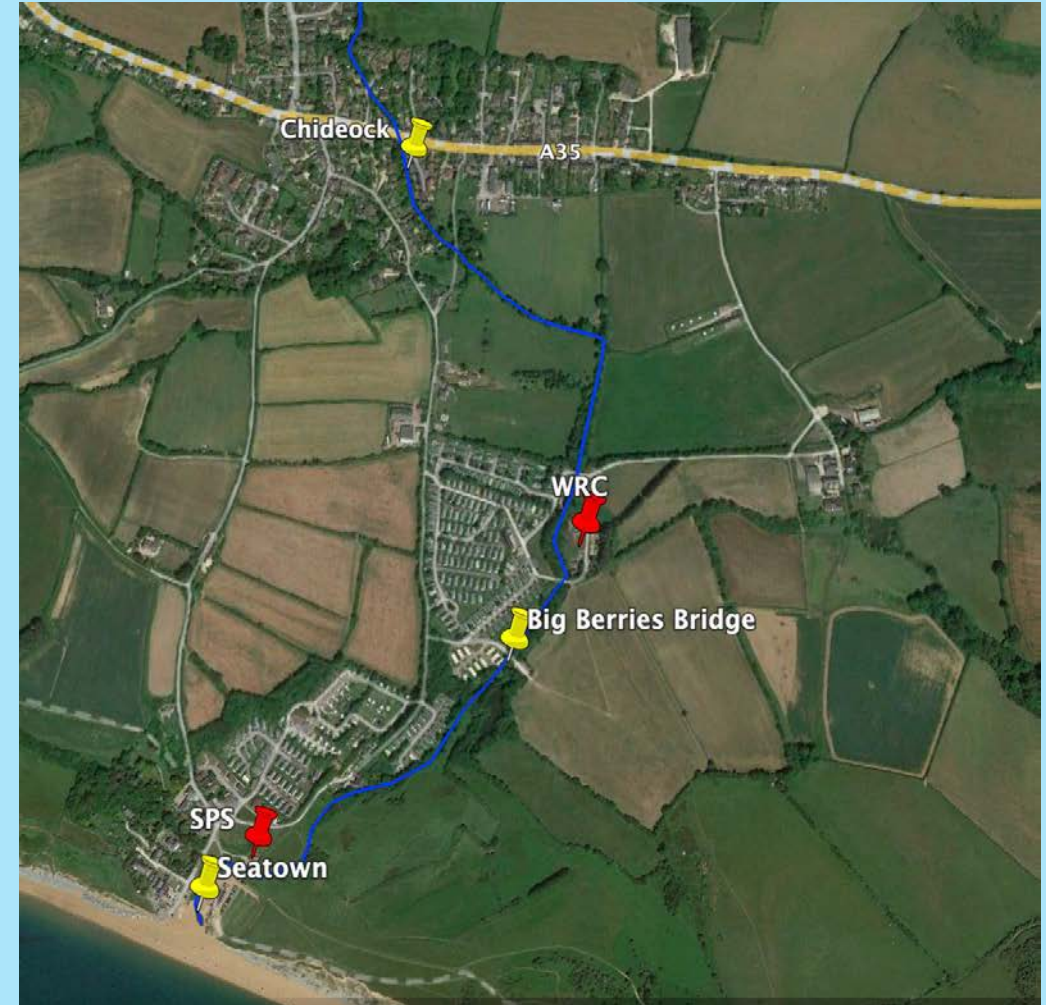
- Design new test plan
 - Focus on Chideock to Big Berries
- Locations
 - Frying Pan - to test Doghouse tributary
 - Attempt to isolate WRC
 - Upstream of storm overflow outfall at WRC
 - Big Berries (downstream of WRC)
 - Seatown
 - Retained as algae was building in the lagoon

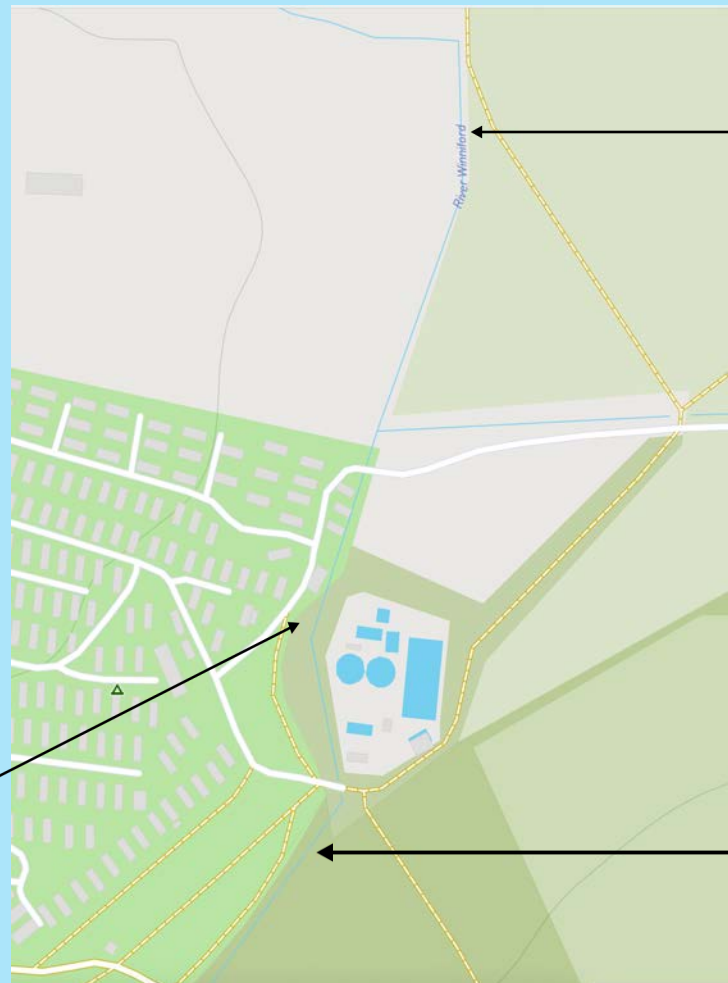
3rd August testing

1. Water level was higher than normal due to rainfall the preceding day

2. Frying Pan: E.coli much higher than expected

3. WRC storm outfall: sample was taken upstream of a (non-active) outfall from WRC and a high level sewer that was seen to be leaking

4. Big Berries: sample was taken just downstream of the WRC main outfall

5. Seatown test result:
E.coli = 11800 cfu/100ml

EA good inland bathing water limit =
1000 cfu/100ml for E.coli

Upstream of WRC outfall
E.coli = 1800

Frying Pan
E.coli = 4000

Big Berries
E.coli = 13600

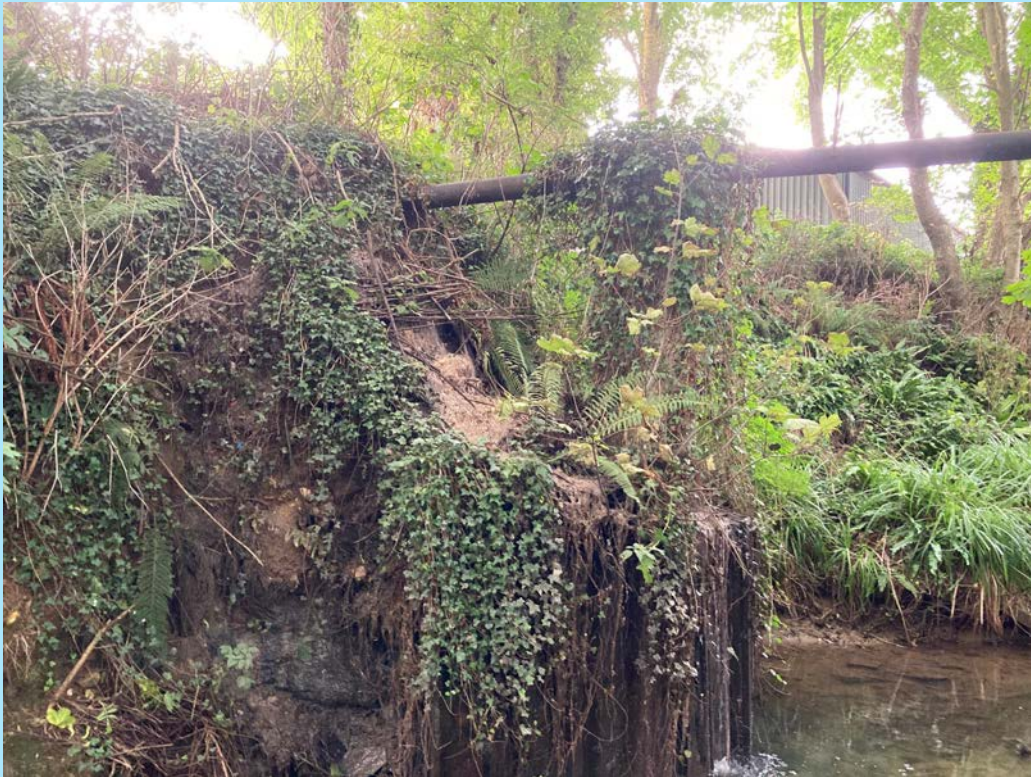
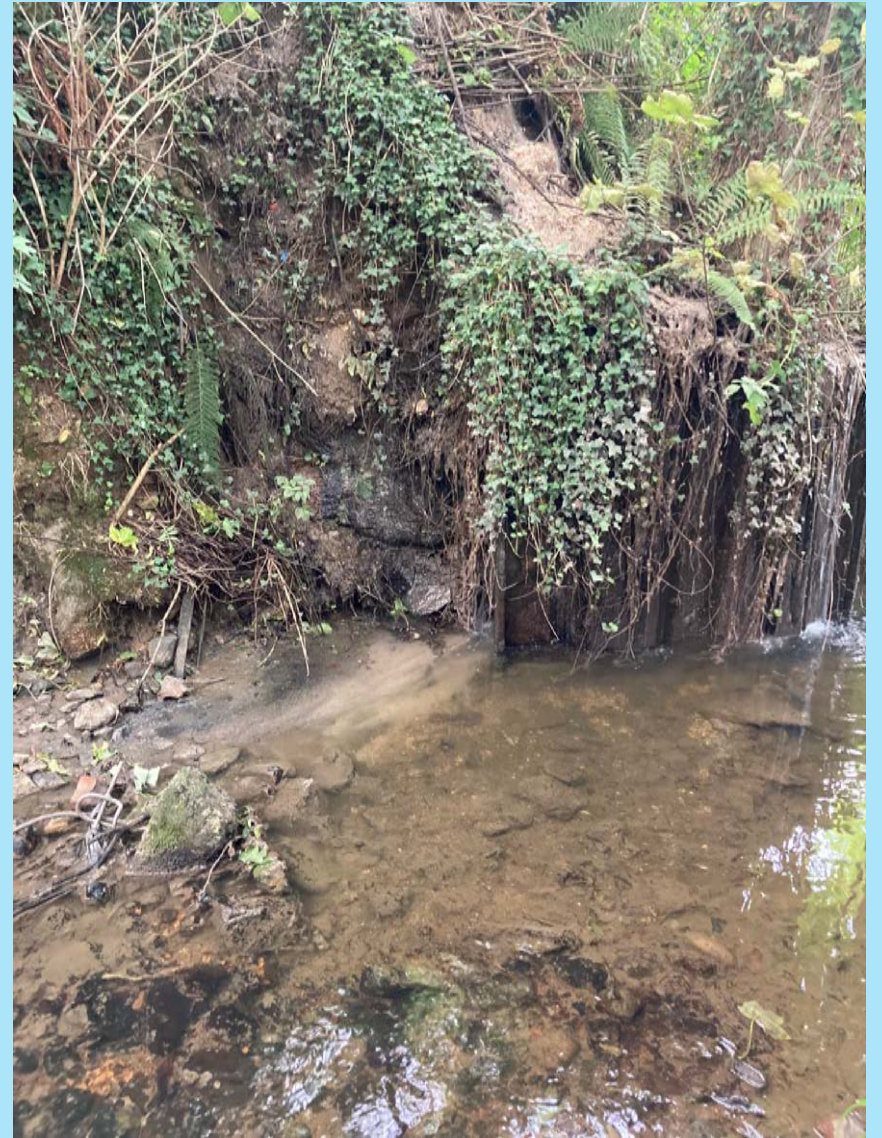
Findings

Effluent leaking into the Winniford from high level sewer linking holiday park to WRC.

- WW had carried out a repair to the sewer very promptly
- Plan to sample four locations
 - Chideock village: Control point
 - Pettycrate Junction: to check if Pettycrate could be a source of pollution
 - Frying Pan: to see if E.coli was still present
 - Big Berries: to check if sewer repair was effective

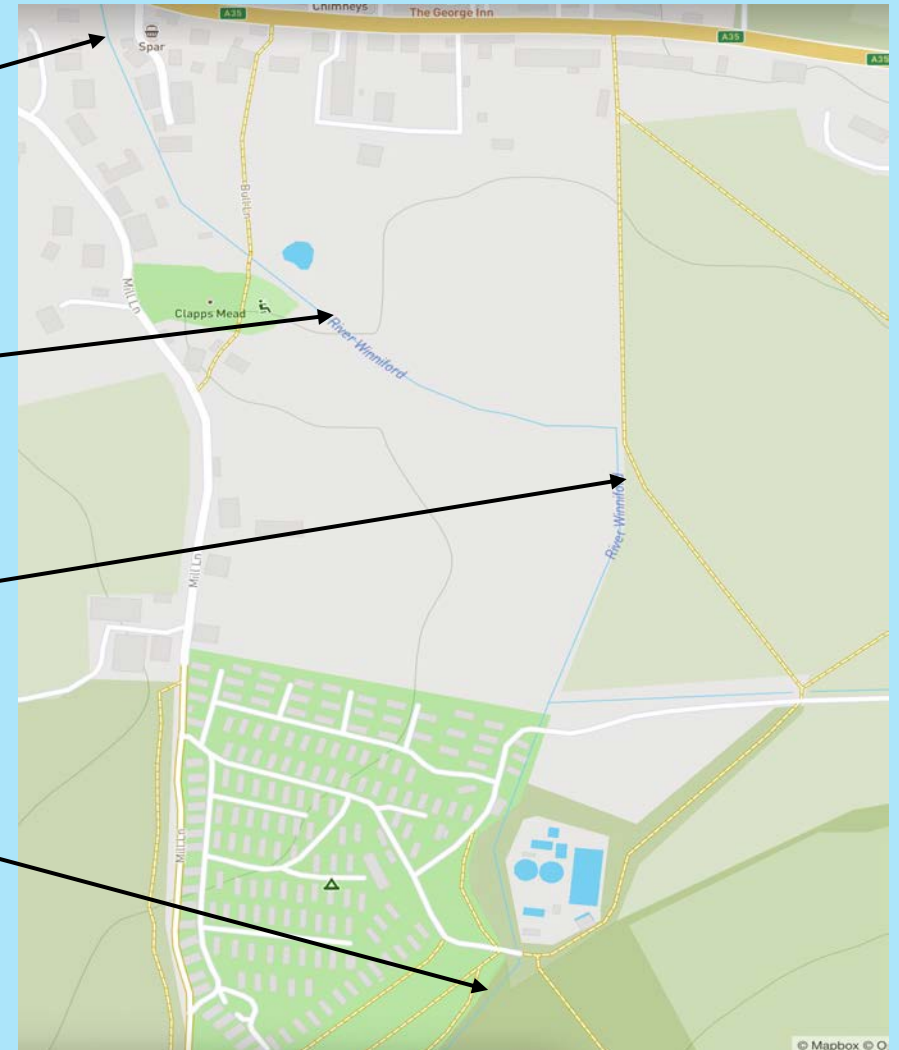
6th September testing

1. Water level was lower than normal, water appeared very clear

2. Chideock Village: Control

3. Pettycrate Junction: Sample taken downstream of Pettycrate tributary, overhead sewer pipe and Cains Farm pond outfall (active)

4. Frying Pan: Sample taken downstream of Doghouse tributary

5. Big Berries: Sample taken just downstream of the WRC main outfall

Chideock Village
E.coli = 1300

Pettycrate Junction
E.coli = 7400

Frying Pan
E.coli = 5300

Big Berries
E.coli = 3000

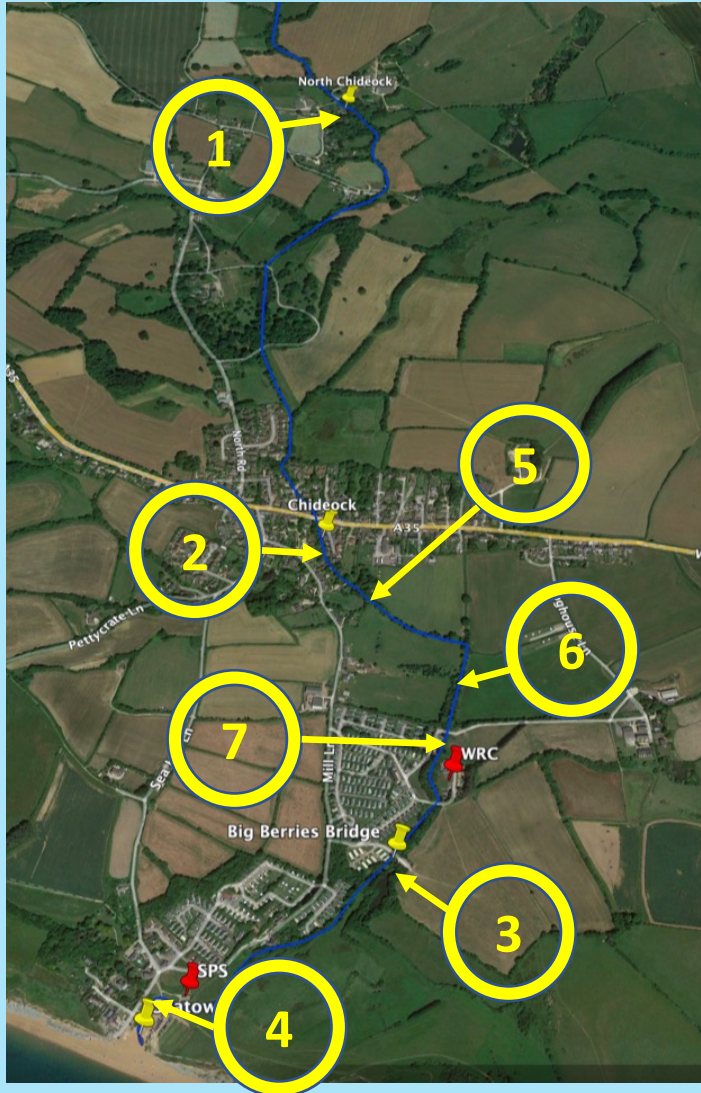
Testing locations updated

Testing points

1. Brighthay Lane, North Chideock
2. Chideock Village (upstream of WRC)
3. Big Berries (downstream of WRC)
4. Seatown (upstream of where the lagoon forms)
5. *Pettycrate junction (downstream of Clapps Mead)*
6. *Frying Pan (just downstream of Doghouse Lane tributary)*
7. *Upstream of leaking sewer pipe*

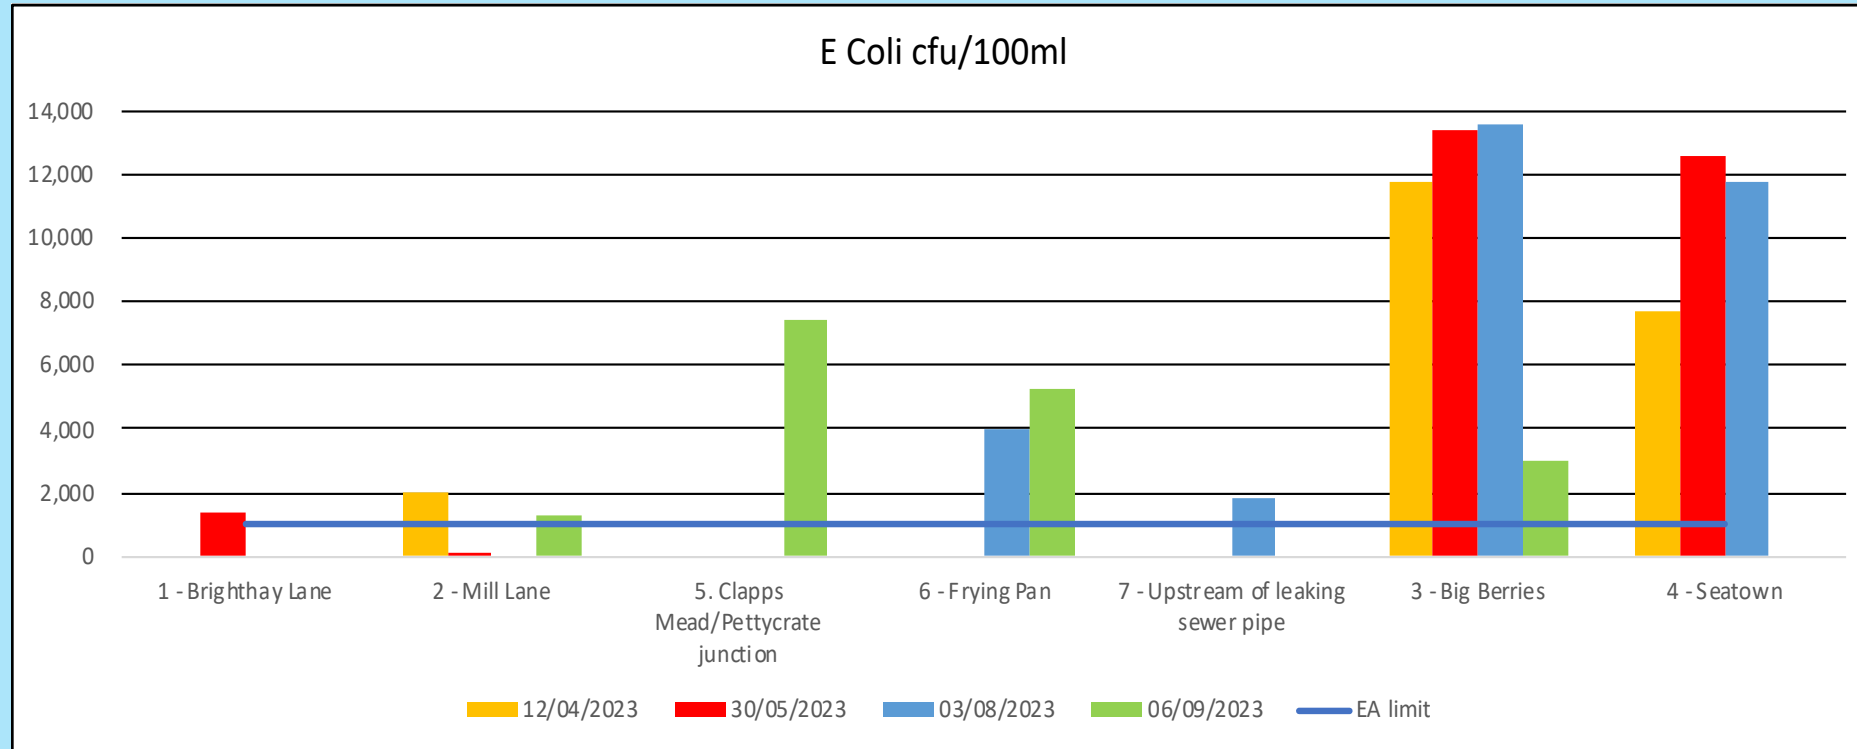
E.Coli testing summary

E.coli cfu/100ml	EA limit	12/04/2023	30/05/2023	03/08/2023	06/09/2023
1 - Brighthay Lane	1,000		1,400		
2 - Mill Lane	1,000	2,000	100		1,300
5. Clapps Mead/Pettycrate junction	1,000				7,400
6 - Frying Pan	1,000			4,000	5,300
7 - Upstream of leaking sewer pipe	1,000			1,800	
3 - Big Berries	1,000	11,800	13,400	13,600	3,000
4 - Seatown	1,000	7,700	12,600	11,800

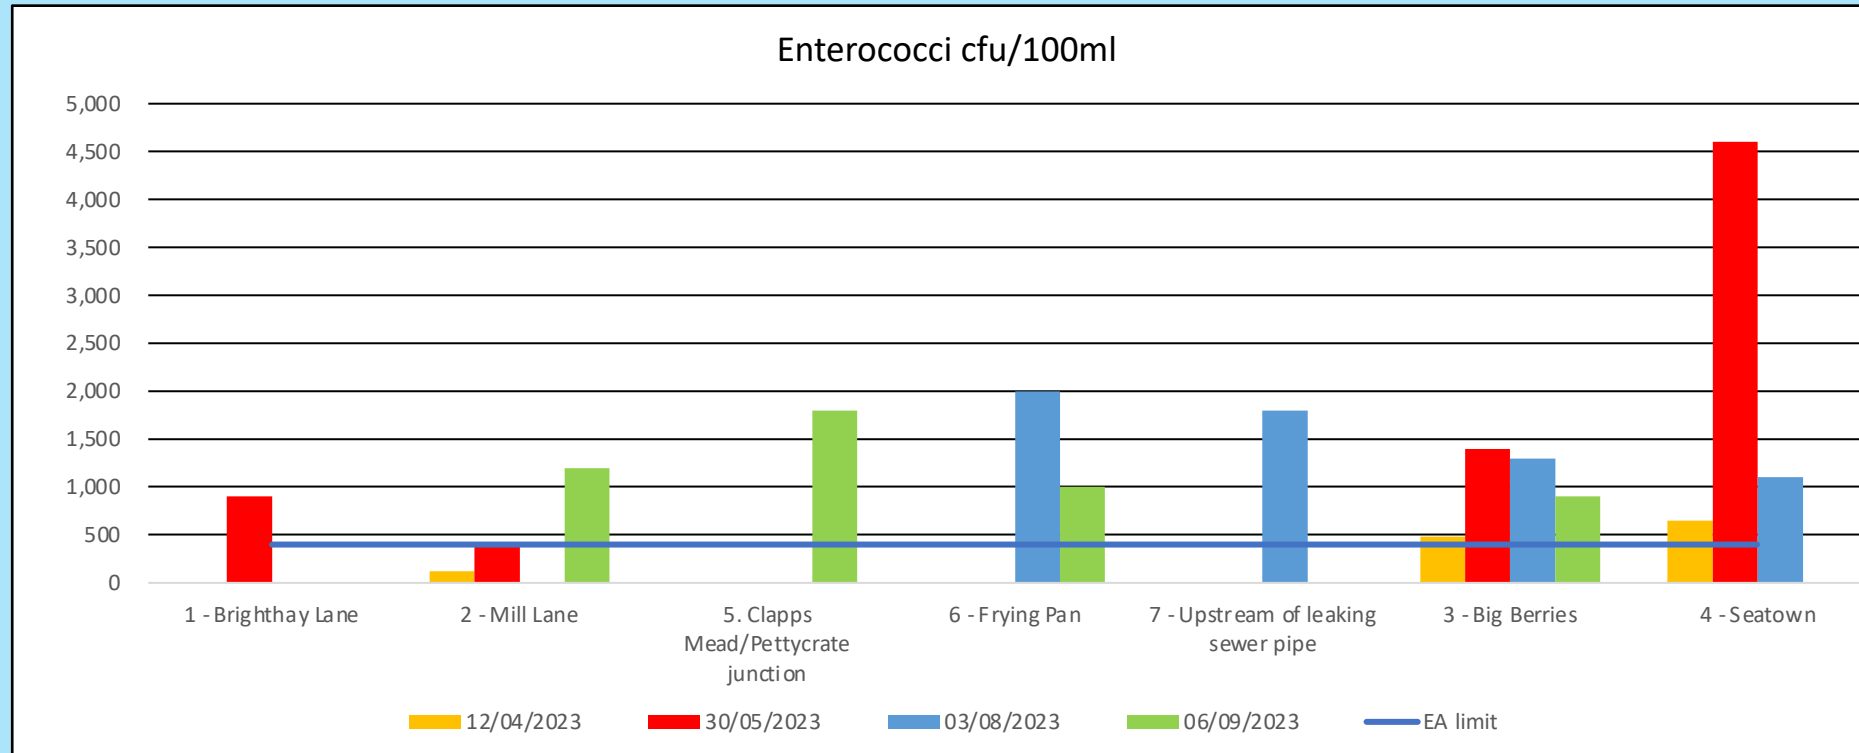
Enterococci testing summary

Enterococci cfu/100ml	EA limit	12/04/2023	30/05/2023	03/08/2023	06/09/2023
1 - Brighthay Lane	400		900		
2 - Mill Lane	400	120	400		1,200
5 - Clapps Mead/Pettycrate junction	400				1,800
6 - Frying Pan	400			2,000	1,000
7 - Upstream of leaking sewer pipe	400			1,800	
3 - Big Berries	400	480	1,400	1,300	900
4 - Seatown	400	650	4,600	1,100

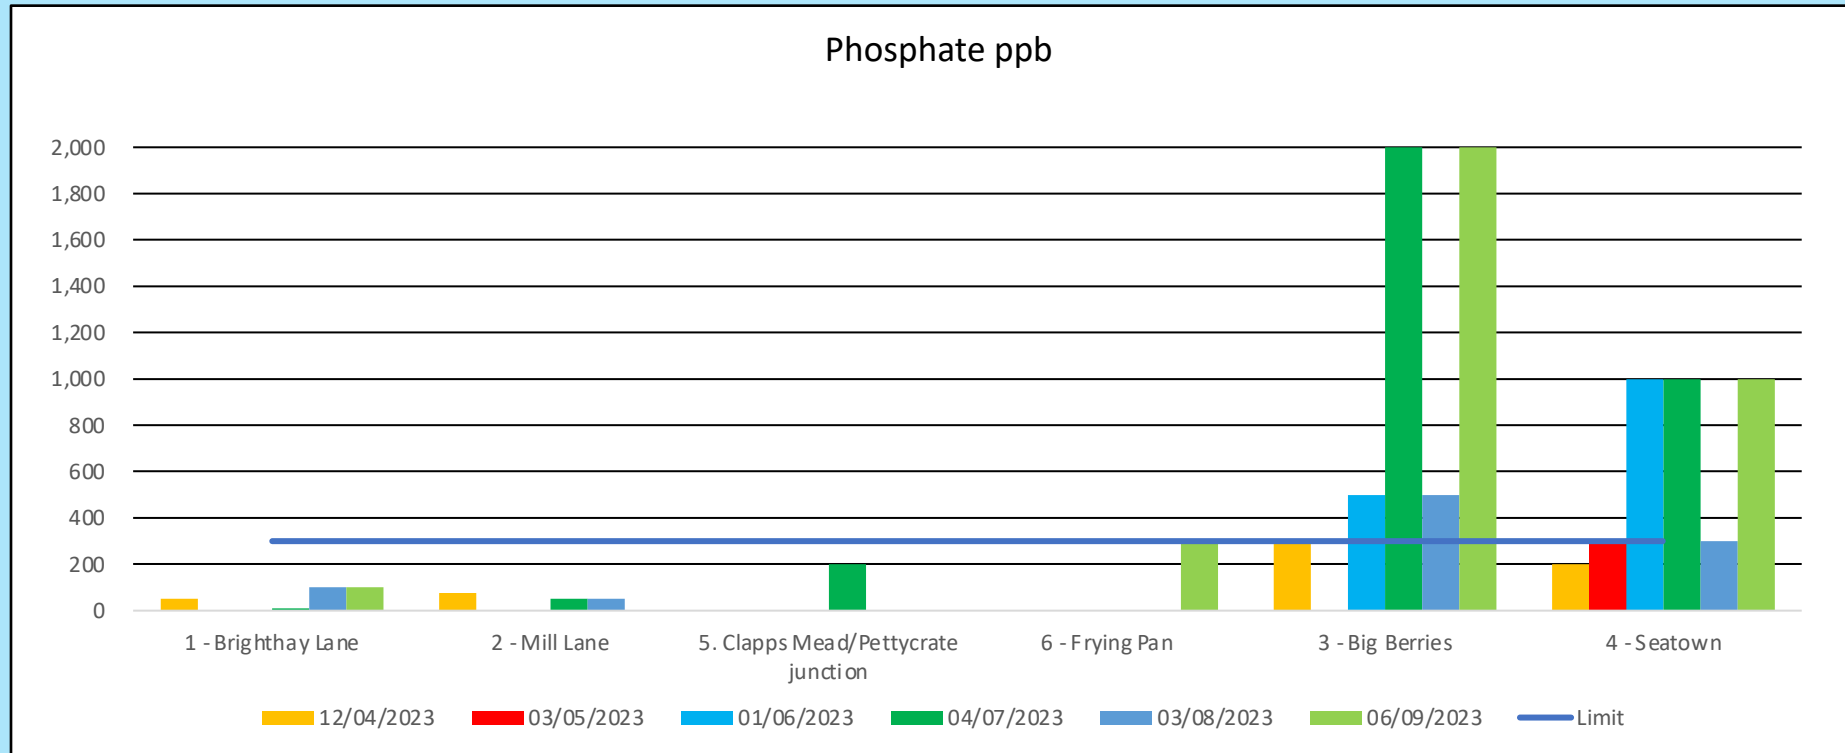
Phosphate testing summary

Phosphate level tested using Insta 'low range' Phosphate strips. These measure Orthophosphate. This is 3x EA measure of Phosphate so our threshold changed to $100 \times 3 = 300$ ppb

Orthophosphate ppb	Limit	12/04/2023	03/05/2023	01/06/2023	04/07/2023	03/08/2023	06/09/2023
1 - Brighthay Lane	300	50		0	10	100	100
2 - Mill Lane	300	75		0	50	50	
5 - Clapps Mead/Pettycrate Junction	300				200		
6 - Frying Pan	300						300
3 - Big Berries	300	300		500	2,000	500	2,000
4 - Seatown	300	200	300	1,000	1,000	300	1,000
