## Permit Extracts

## EA & Ofwat agreed capital improvements completed

## 2022 Bathing Water Profile for Seatown

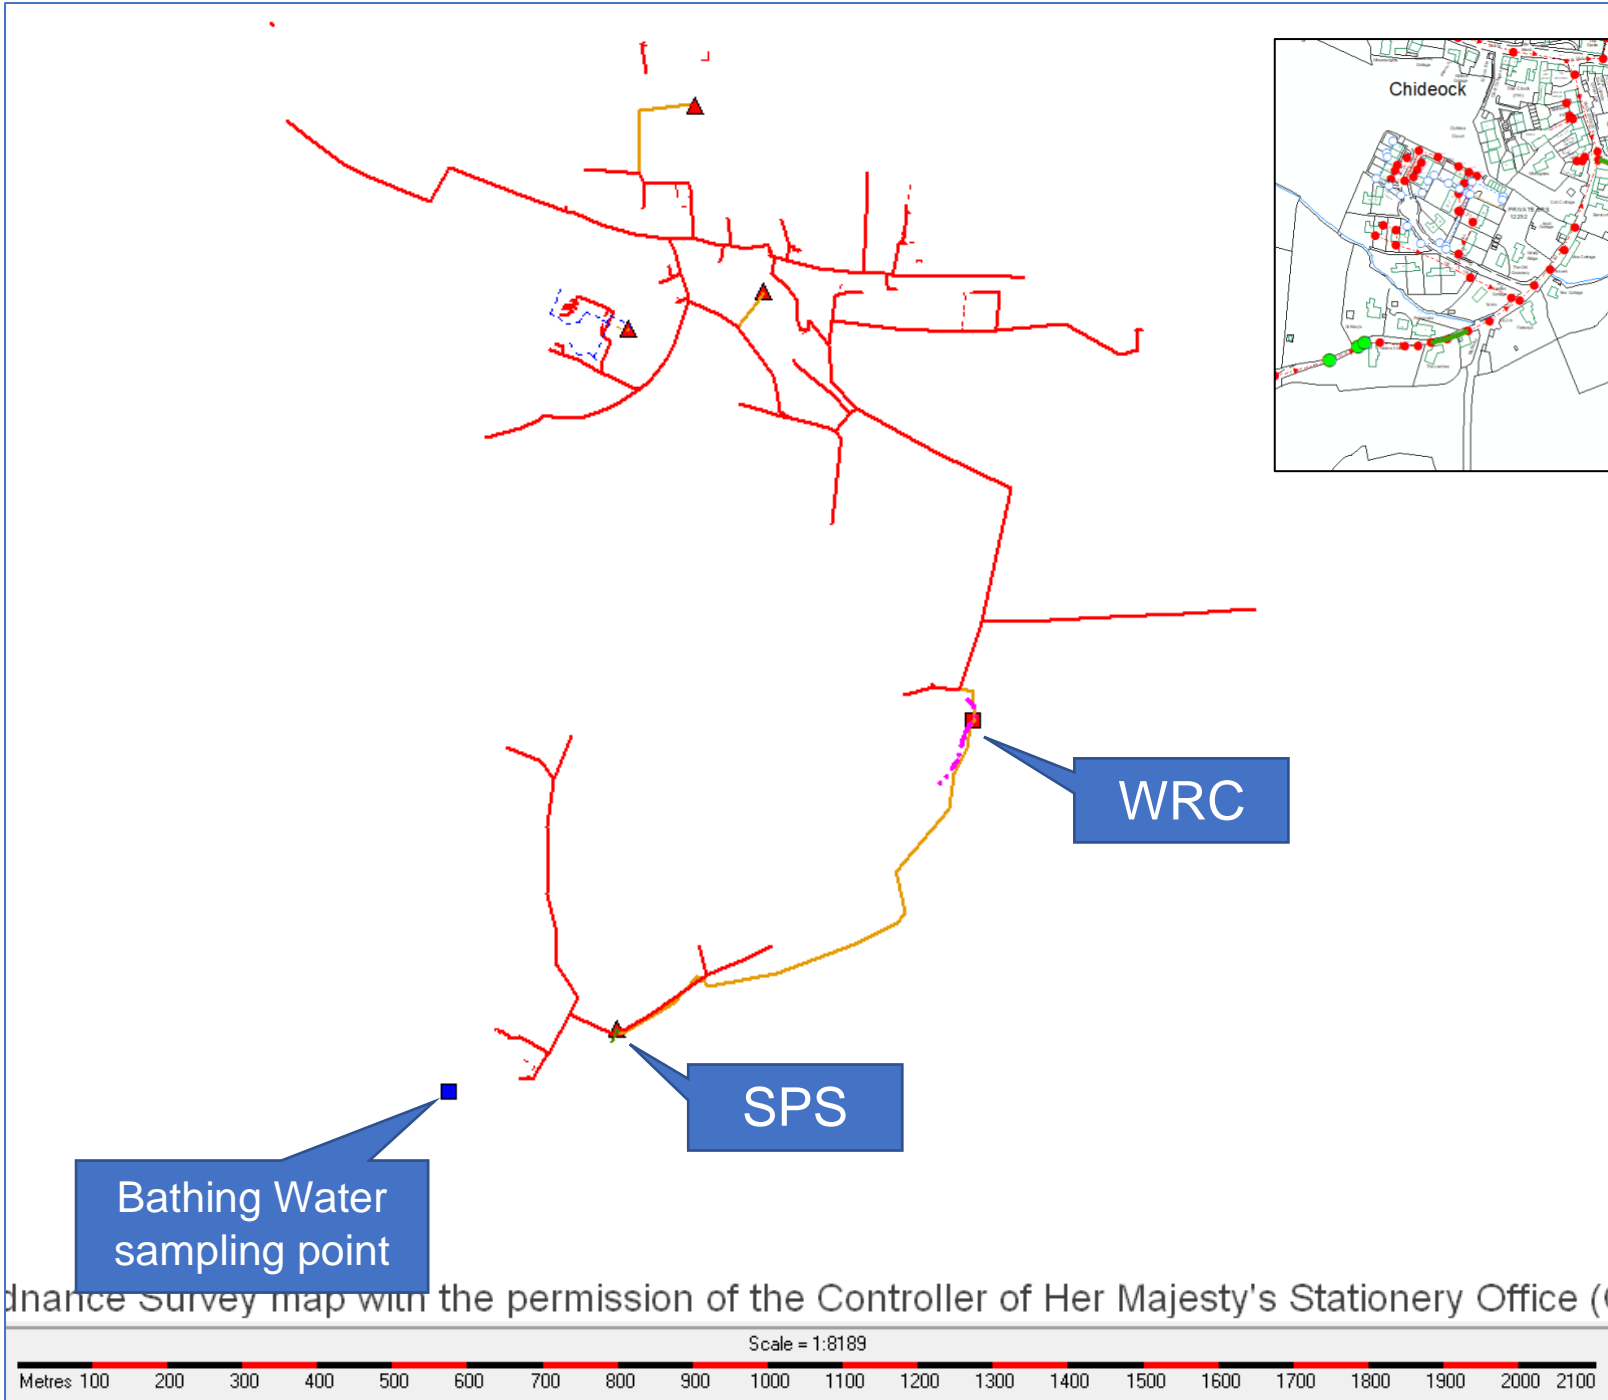
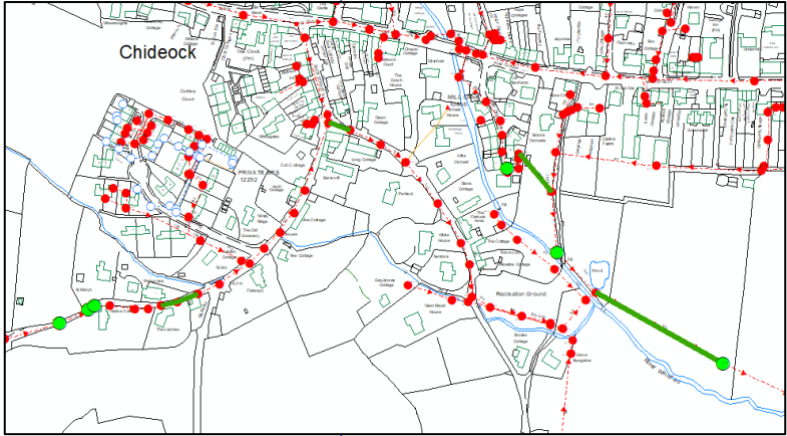
Scheme Reason	Technical Description	Date
Seatown SPS has inadequate capacity, causing discharges of sewage from the SO into the stream which feeds a paddling pool on the beach.	<ol style="list-style-type: none"> <li>1. Uprate Seatown SPS</li> <li>2. Provide storm rising main to Chideock STW</li> <li>3. Provide storm tank at Chideock STW (77m3)</li> <li>4. Improve flow to treatment control</li> <li>5. Provide storm pumping</li> </ol>	1998
UV disinfection is required at the WRC to comply with the Bathing Water Directive together with storm storage sufficient to reduce storm spills to three per bathing season.	<ol style="list-style-type: none"> <li>1. Install UV disinfection plant</li> <li>2. Provide standby power generation</li> <li>3. Provide additional storm tank (180m3 capacity) to give total storage of 257m3</li> <li>4. Provide Inlet Fine Screen (6mm)</li> </ol>	2002

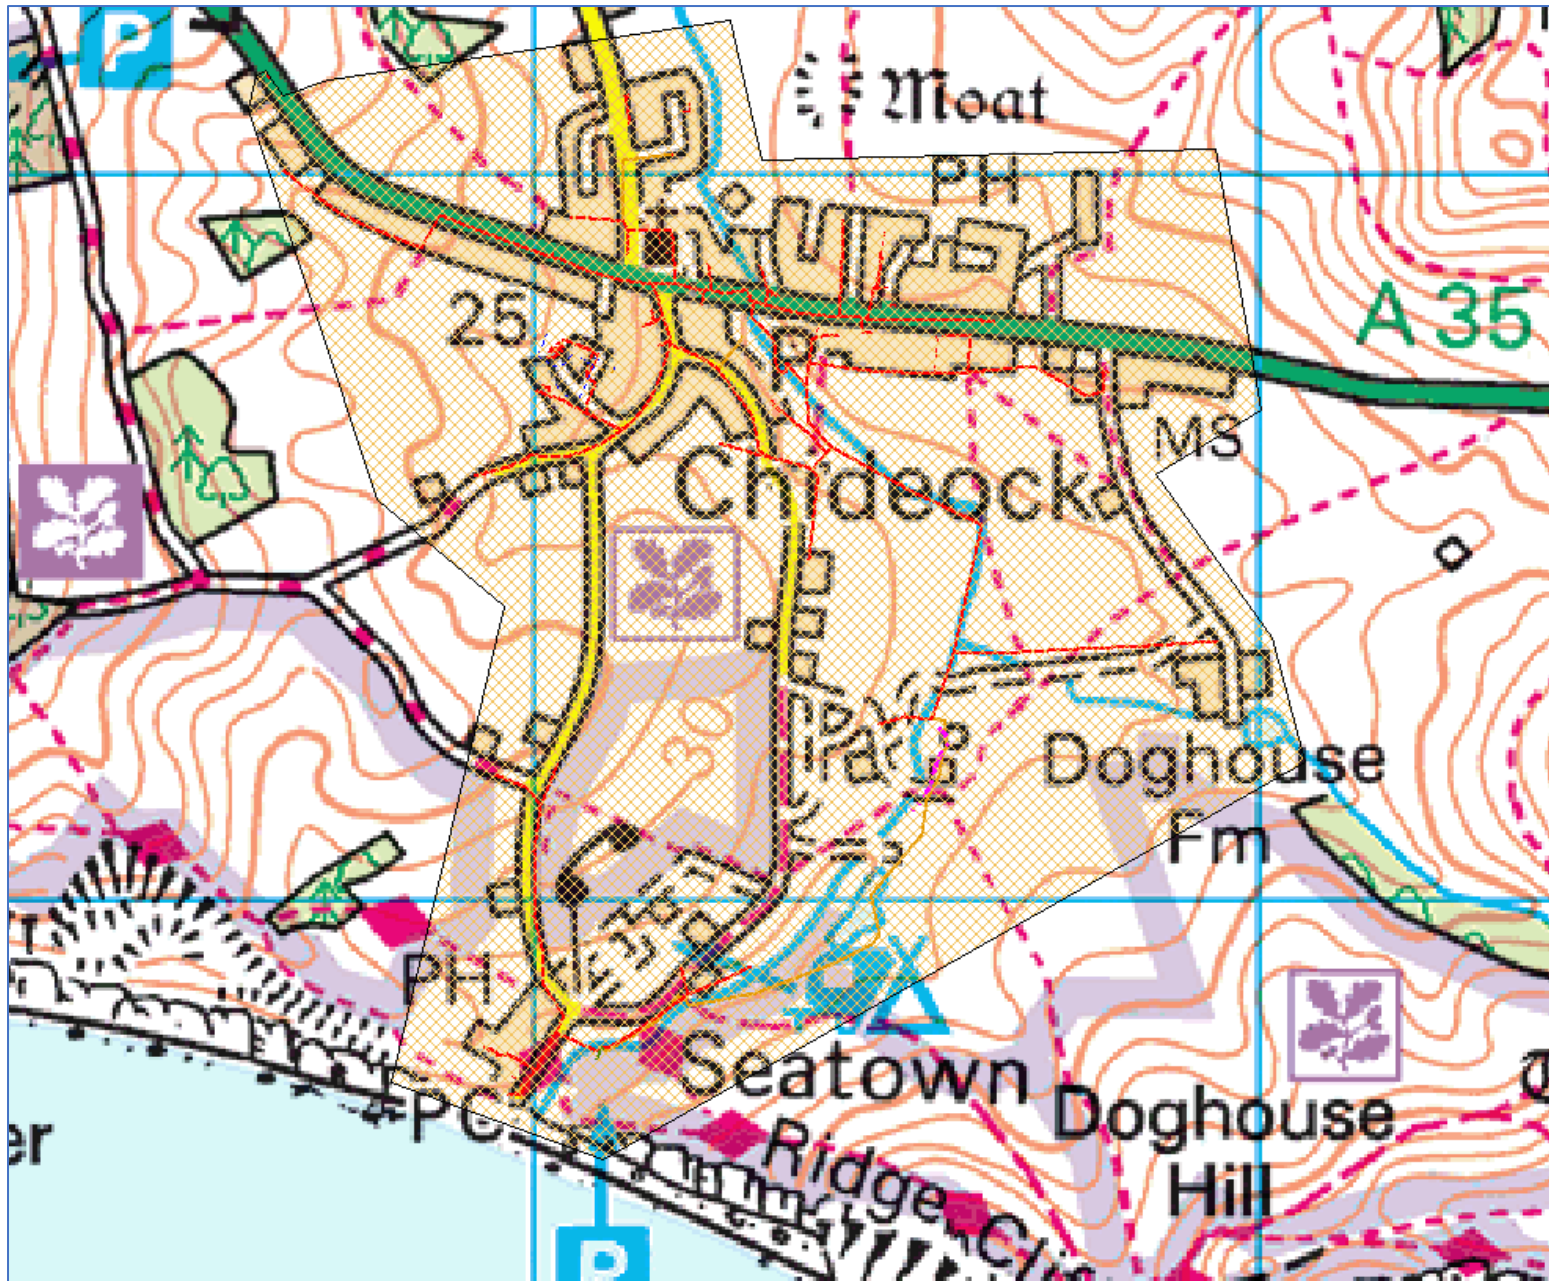
Plan Ref:	Description
A	Influent sampling point
B	Final effluent outfall
C	Final effluent before UV disinfection sampling point
D	Final effluent after UV disinfection sampling point
E	Settled storm outfall
F	Settled storm sampling point
G	Site main entrance
